**DEVELOPMENT TESTS AND FLIGHT TEST OF GRAPHITE
COMPOSITE LANDING GEAR SIDE BRACE ASSEMBLY
FOR A-37B AIRCRAFT**

TECHNICAL REPORT AFFDL-TR-77-56
Final Report for the Period 15 May 1973 to 15 March 1977

20. ABSTRACT (Continue on reverse side if necessary and identify by block number) This report describes the successful development, in-house testing, and flight testing of a graphite/epoxy side brace for the A-37B aircraft landing gear.

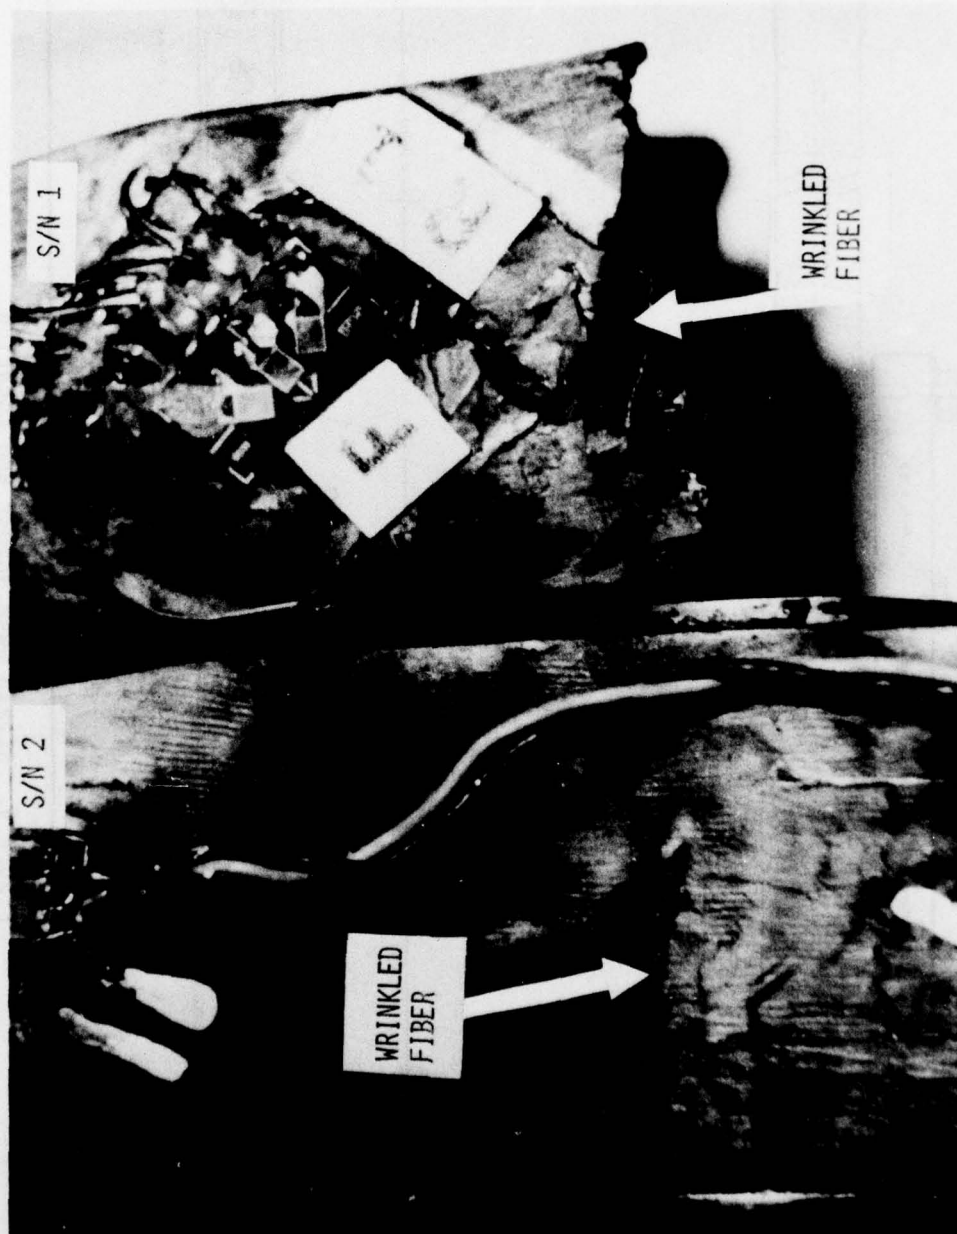
Figure 8. Comparison Between Broken S/N 1 Lower Member and Substitute S/N 2 Lower Member After 4 Lifetimes

Figure 8 illustrates the broken S/N 1 lower member (on the right) vs a similarly wrinkled surface on the S/N 2 lower member. As mentioned above, these wrinkled areas made the parts highly suspect from the beginning. Even with the obvious fiber wrinkling, the S/N 2 lower member withstood over four (4) lifetimes of the fatigue spectrum (Table 2). After approximately four (4) lifetimes of the fatigue test, some small cracks became evident in the chopped fiber regions of the S/N 1 upper members. One of these cracks is shown in Figures 12 and 13. The crack shown in Figure 12 was found after four (4) lifetimes and Figure 13 shows the same crack after five (5) lifetimes. After attaining over four lifetimes on the S/N 2 lower member and six lifetimes on the S/N 1 upper members, it was decided to increase the fatigue loads by 25%. When this was done, the assembly failed catastrophically at approximately 20,000 lbs compression. Strain data were being taken at the time of the failure and strain gage No. 12 registered approximately 2500 μ . Figure 14 shows the failed assembly. Figures 15 and 16 show the failed lower and upper members, respectively. It is difficult to determine which part in the assembly failed first, but it is believed that the S/N 2 lower member failed first. After this failure, the lower member was further redesigned in the tang area.

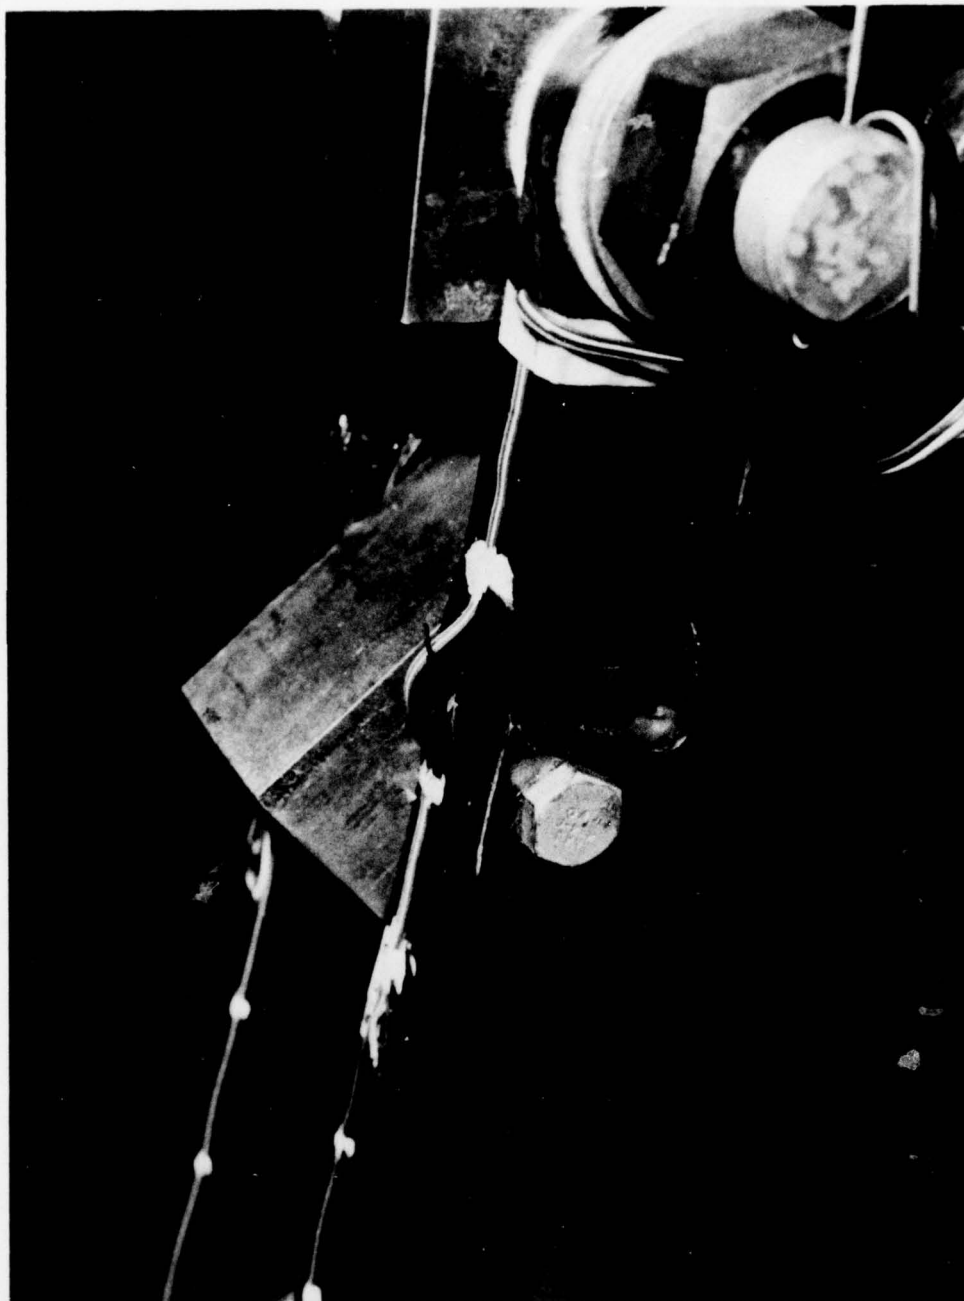
Figure 16. Failed S/N 1 Upper Members After 25% Increased Load (6 Lifetimes on Upper Members)

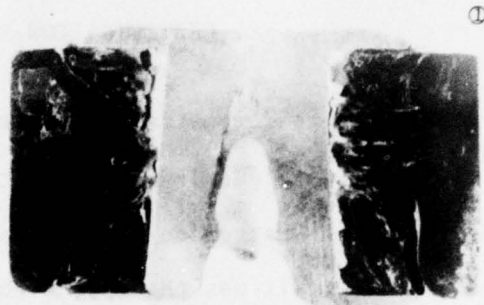
These parts and several others were eventually sectioned to determine what made them opaque to ultrasonics and transparent to x-rays, and possibly determine why they failed as they did. After sectioning, potting and polishing the specimens, definite voids and lack of fibers near the bushings of the defective side braces became evident (Figure 22). These are almost definitely what caused the parts to fail prematurely. This unexpected dividend from the environmental test program gave a good data base upon which to judge the flight test hardware and its NDI results.

Figure 22. Sectioned Views of Defective Side Braces Showing Voids, Lack of Fiber, and Some Fracture Damage from Static Tests

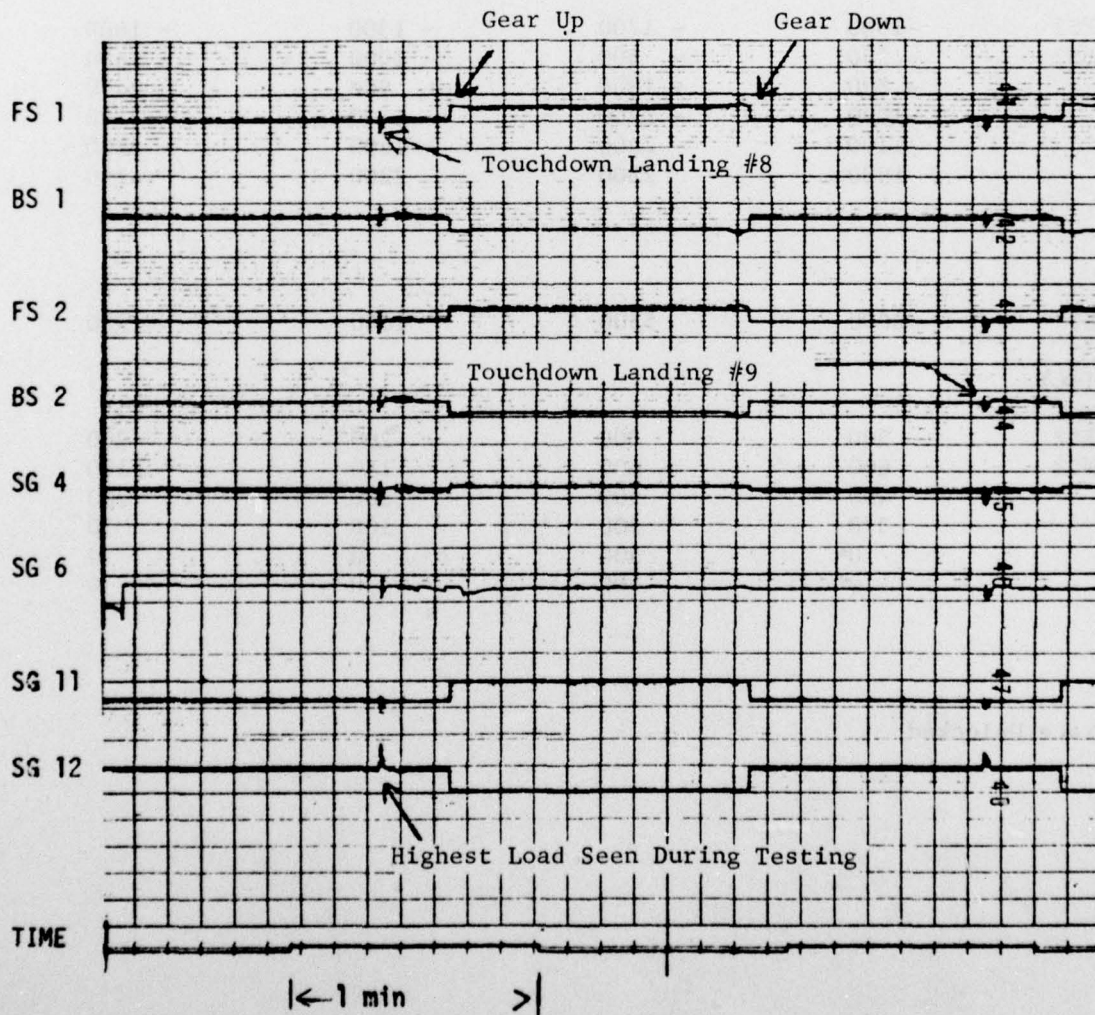
SAMPLE STRAIN DATA

This section of strip chart shows the strain data from landings 8 & 9 of the second flight. The bending load imposed on the side brace by the overcenter downlock spring is clearly seen on all channels except SG6, which is located on the neutral axis of the lower arm. On this particular flight there is some noise on SG6. The data shows that even severe landings such as this produce relatively low strains. On landing 8 SG 12 records the highest load seen on the test. This impulse load corresponds to a load of ≈ 5000 lbs, or $\approx 30\%$ of T37 design limit load.
